# Sutton Courtenay FRA Evaluation

February 2013

Dr Harvey J E Rodda

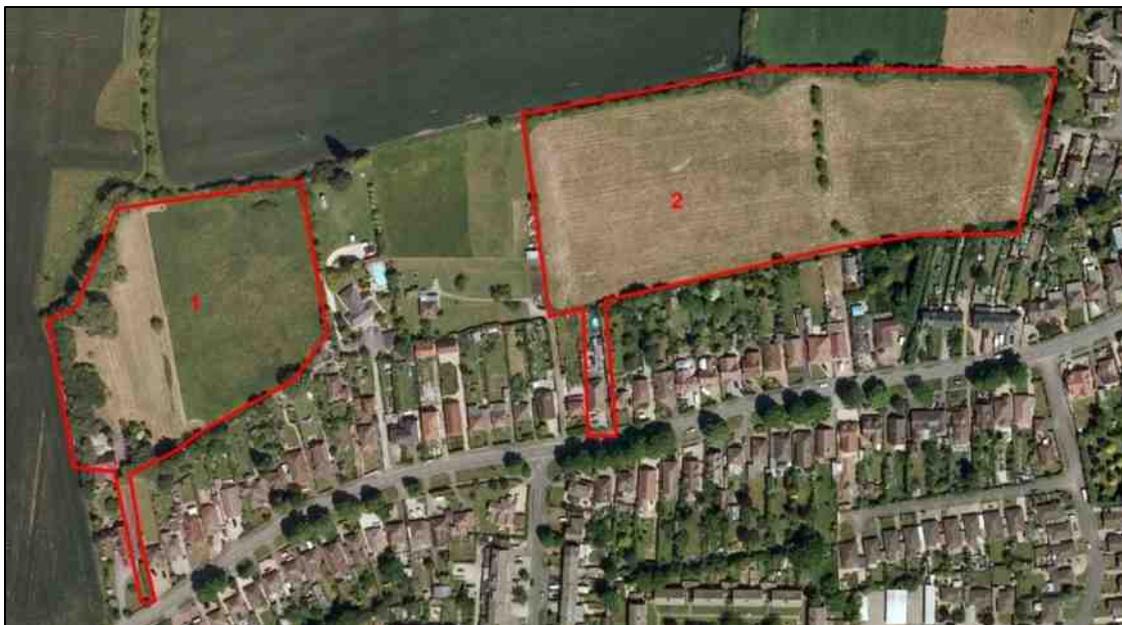
Figure 1: Aerial photo of Sutton Courtenay showing the development sites in red: 1) Pye Homes, 2) Redrow Homes.  
Source: Infoterra 2013 scale 1:2500

The Milton Road development site is located in Oxfordshire in the village of Sutton Courtenay, some 2.5km north west of Didcot. The development sites in total covers an area of 4.53 ha in the south west of the village, but immediately to the north of properties along the Milton Road. . The Pye Homes site to the west covers 1.66 ha and the Redrow Homes site to the east covers 2.87 ha. The site is situated on the flood plain of the River Thames, as evident from the descriptions of topography and geology in the following sections. The flood plain in this sense refers to the landscape unit rather than the flood outlines which are often incorrectly used as defining land to be within the flood plain. In terms of the local hydrology, the site is within the catchment area of the Ginge Brook, a tributary of the River Thames, which flows in a southwest-northeast direction. The detail of the site location is shown in Figure 1. The site in relation to the Ginge Brook catchment is shown in Figure 2. Both development sites are bordered by the existing residential area to the south with farmland to the north and west. The eastern border of the Redrow site is also delineated by existing properties.

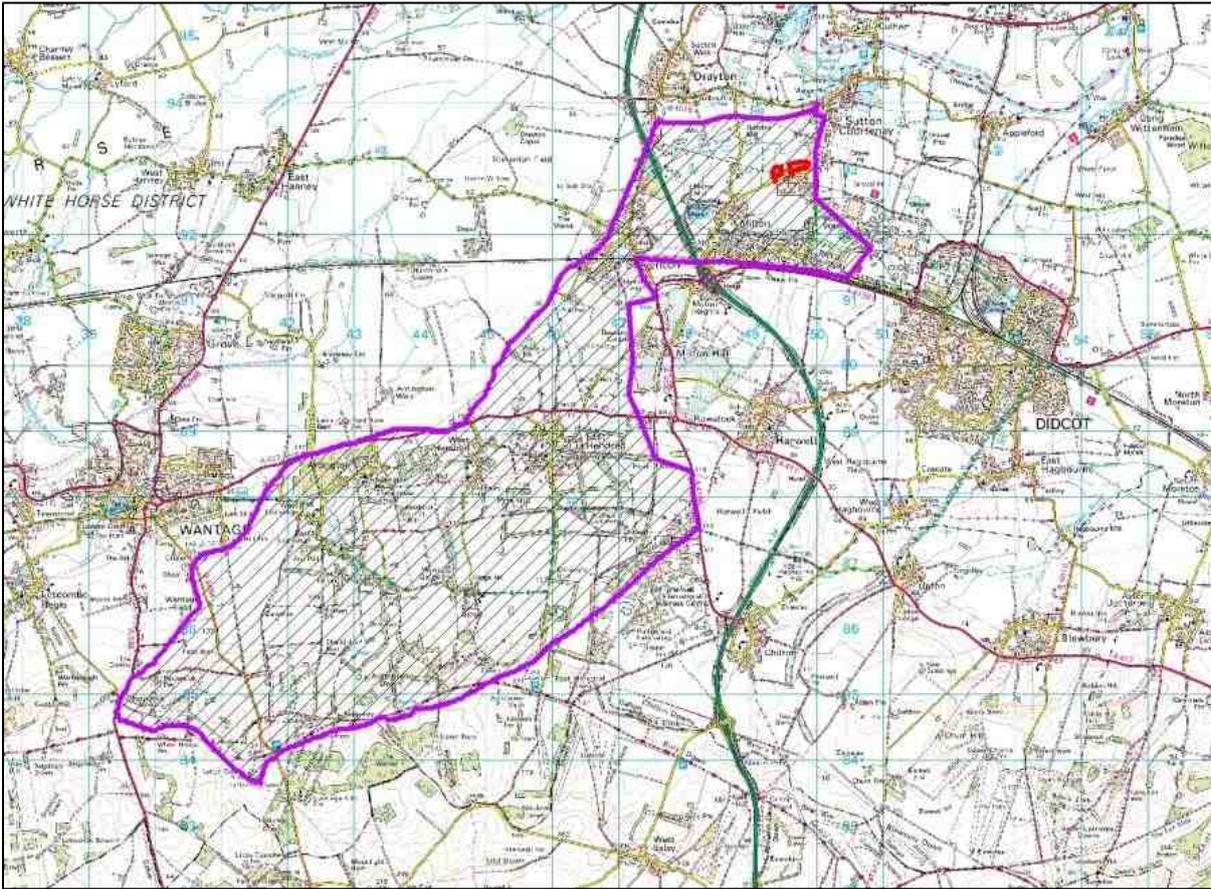
Figure 2: The location of the Sutton Courtenay development sites (red outline) in relation to the Ginge Brook catchment (purple outline). Background Map OS 1:50000 Sheet 174.

The development sites are within the Ginge Brook catchment, which drains an area of 39 km<sup>2</sup> and flows from the foot of the Berkshire Downs some 8km to the south. The watershed on the Downs has an altitude of over 200m AOD and the Ginge Brook emerges at springs with an altitude of around 125m AOD, and flows to meet the Thames at below 50m AOD. Over half of the catchment area is over the permeable Chalk, while the remainder drains areas underlain by Greensand and impermeable Gault and Kimmeridge Clays to the north. The northern areas of the catchment, around Sutton Courtenay and Appleford also have extensive superficial deposits of river alluvium, sand, gravel and clays from terraces deposited as part of the former course of the River Thames. The areas of sand and gravel in particular give rise to more permeable areas locally. The Ginge Brook catchment has a base flow index of 0.85, meaning that the brook is predominantly groundwater fed due to the large contribution from the chalk.

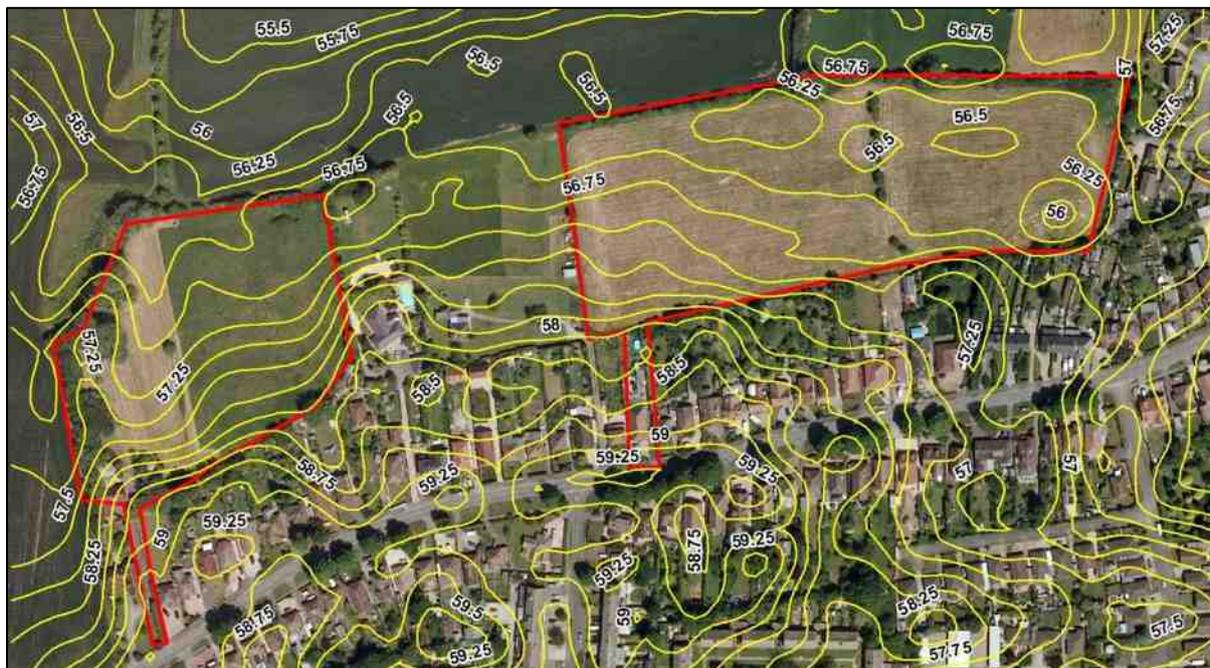
Figure 3: The topography of the development sites and surrounding area.

The site is an area of rough grazing with sparse bushes and bordered by larger trees. It is generally flat to undulating in terms of the surface topography with an altitude of approximately 57m AOD. A more detailed representation of the topography is shown by the contour map in Figure 3. The contours are taken at 0.25m intervals from a digital terrain model (DTM). This is a computer representation of the ground surface with spot height measurements at regular 5m intervals from an aerial survey generated by Infoterra. The development sites both slope in a general south to north direction. The Redrow site levels range from 58m AOD along the south western edge to 56.25m AOD along the north-eastern boundary. There is also a circular depression of below 56m AOD in the south-eastern corner, and the land does rise again by 0.5m just after the northern boundary. The Pye homes site has a similar range of levels but slightly higher from 59m AOD in the south-west to 56.25m AOD along the northern boundary. Both sites are downslope from the houses along Milton Road, and the road itself is marginally higher at a maximum of 59.25m AOD. The general slope continues northward 300m from the site boundaries to the Ginge Brook at 54m AOD. Land to the south of Milton Road is lower again in altitude dropping below 59m AOD apart from a small area south of the Pye Homes site where levels rise up to 59.25m AOD.

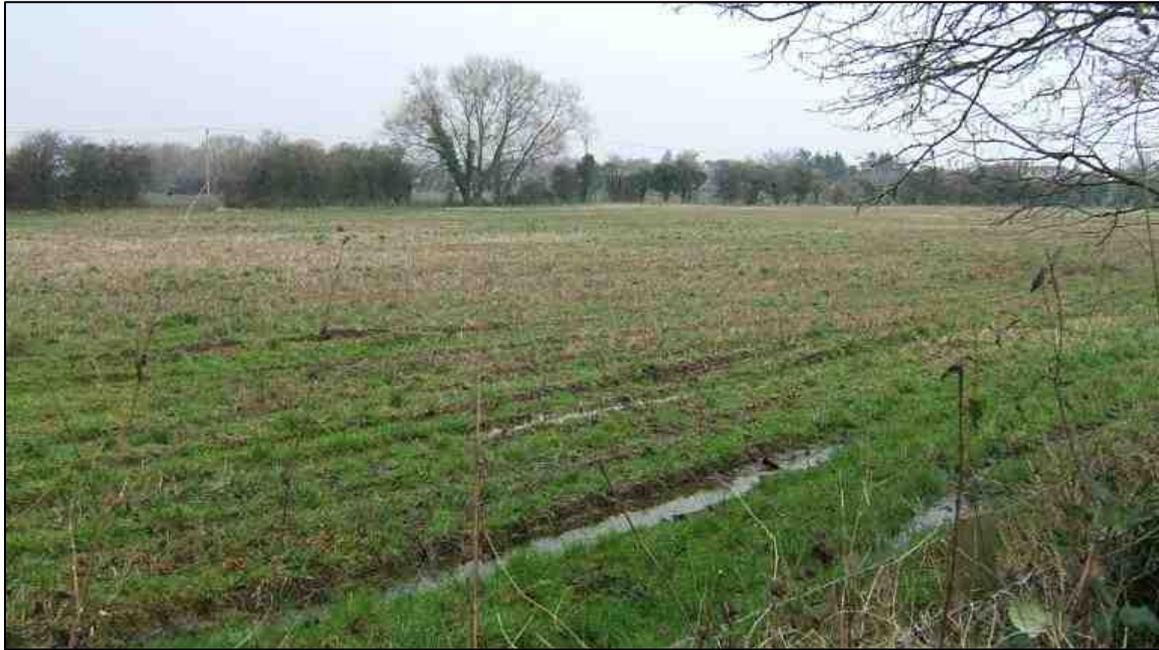
The site is poorly drained and surface ponding is common during the winter or following periods of heavy rain (Figure 4). The Soil Survey of England and Wales maps (1981) show the sites to be at the boundary of the Thames and Sutton 1 soil series. Thames soils are poorly drained clays which are seasonally waterlogged located close to rivers and overlying impermeable alluvium and clay. The Sutton 1 series are more freely draining clay loams overlying sands and gravels but can be affected by

Figure 4: View across the development site from 64 Milton Road looking east, showing water logging.

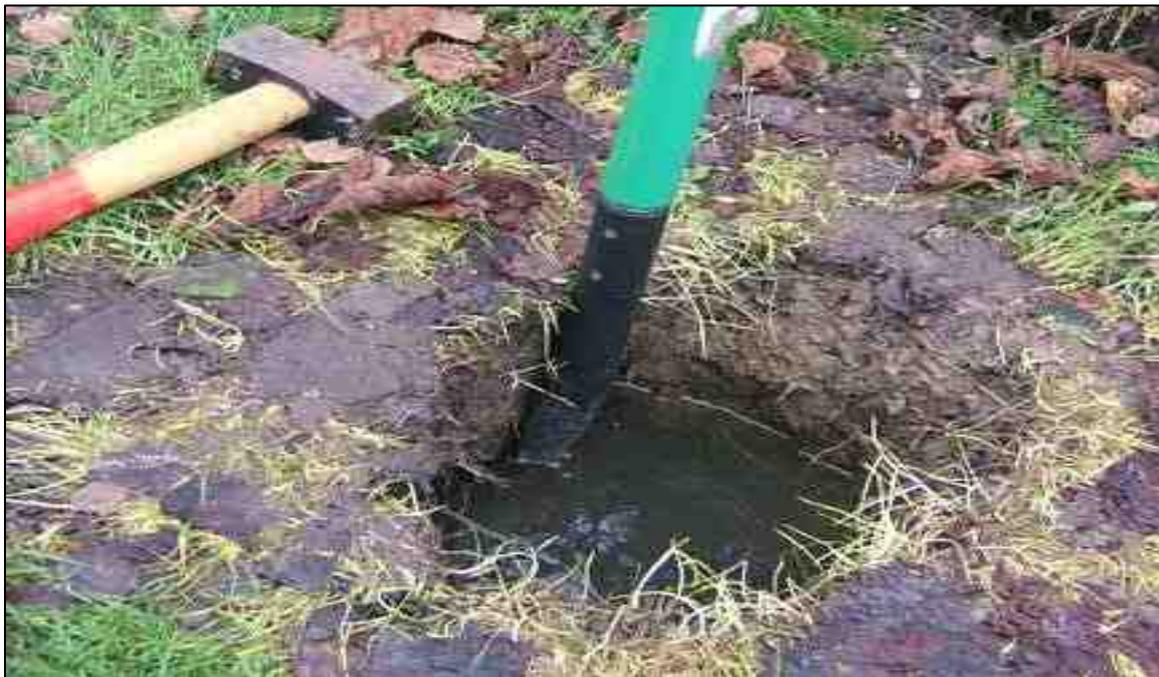
rising groundwater during wet periods. Thames soils are left for grazing but Sutton 1 soils are used for arable farming. Infiltration tests on the soil in the garden of no. 64 Milton Road at a point 7m from the Redrow Homes site during February 2013 found the soils to be saturated with infiltration of just 10mm/hr. A nearby hole showed water at a depth of 0.16m (Figure 5), and the mottled grey/light brown colour of the soil would suggest this is the Thames series and water has seeped out from the topsoil and ponded over the impermeable clay. It is not possible to precisely define the soil type without reference to a proper soil profile from a trial pit or soil auger cores.

Figure 5: Water at 0.16m depth in the garden of No. 64 Milton Road, 7m from the southern boundary of the Redrow Homes site.

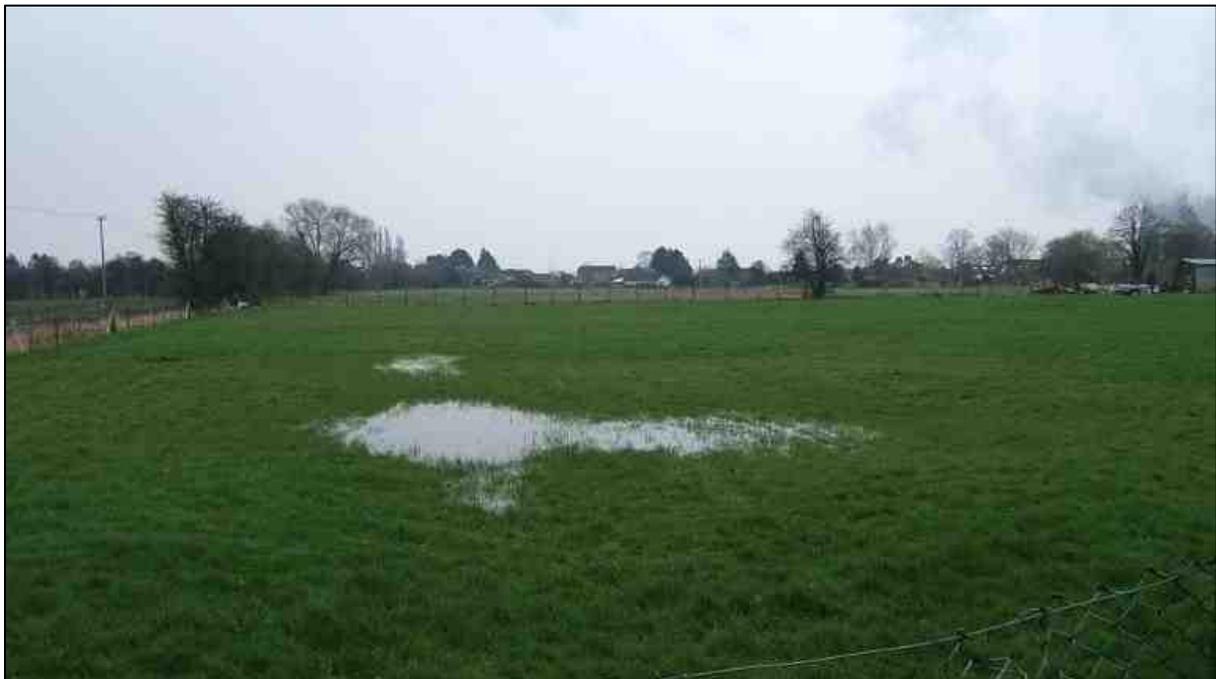
Areas of standing water were visible in both development sites and in particular standing water was at a depth of 0.2m along the edge of the Pye Homes site next to the north-west corner of the development. These could also be on areas of Thames soils with the impermeable clay or in the Sutton 1 series where depressions make the rising groundwater pond over the surface. High groundwater would be expected given the time of year and the very wet conditions experienced in 2012 from April through to December. Residents at 90A Milton Road, on the eastern border of the Pye Homes site also experienced considerable surface water ponding of their garden in February 2013, which extended into the neighbouring paddock in the land between the two development sites, as shown in Figure 6.

Figure 6: Surface water in the land between the two development sites, looking east towards the Redrow Homes site.

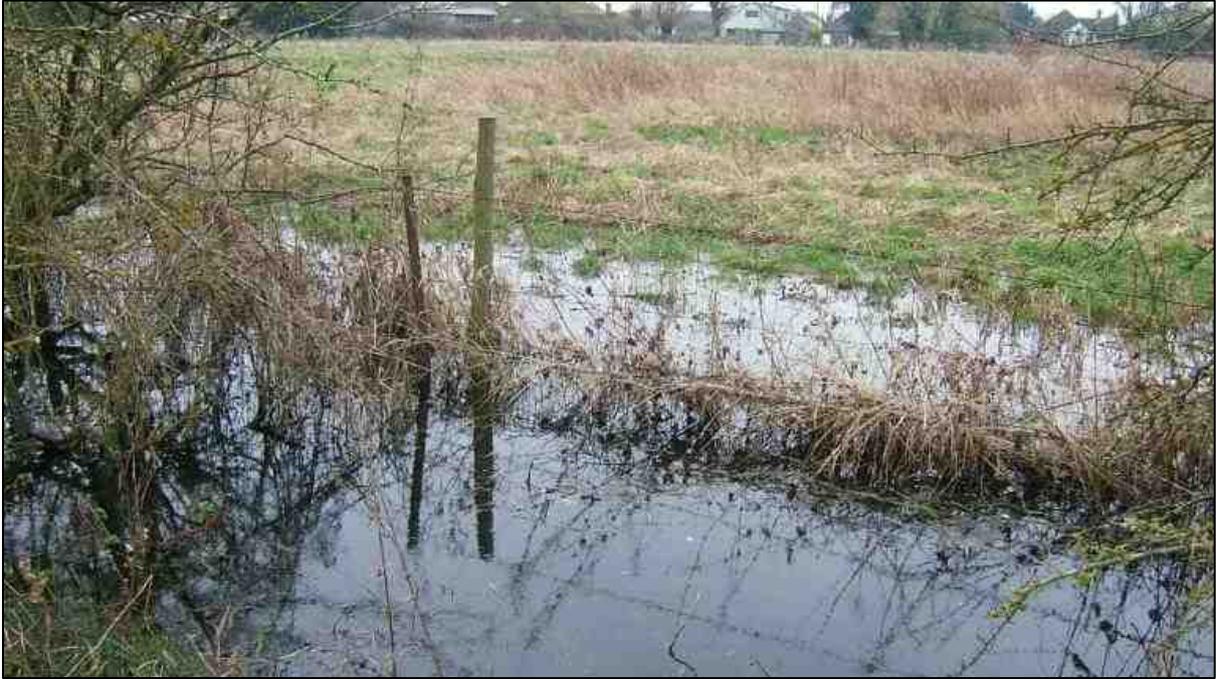
Drainage ditches flow around the western perimeter of the Pye Homes site and along the northern perimeter of the Redrow Homes site then north into Ginge Brook approximately 300m away. In February 2013 the ditch along the western edge of the Pye Homes site was observed to be spilling over its banks with standing water in the development site (Figure 7). There was no obvious flow of water and vegetation growth had contributed to reducing the ditch capacity and its ability to convey water away from the site. From the topography it is clear that with the general south-north slope the natural drainage pathway would be from Milton Road and the houses along its northern side to the development sites. This would include both surface runoff over impermeable and saturated areas and sub-surface flow through the unsaturated permeable soil layers. The surface depression areas in the Redrow Homes site would be particularly susceptible to standing water.

Figure 7: The ditch flowing along the western boundary of the Pye Homes site, currently exceeding capacity with the houses on Milton Road in the background.

Furthermore the maps only cover the main rivers which are those shown by the dark blue lines. The flood risk from the smaller ditches flowing from the development sites (e.g. Figure 7) is not shown.

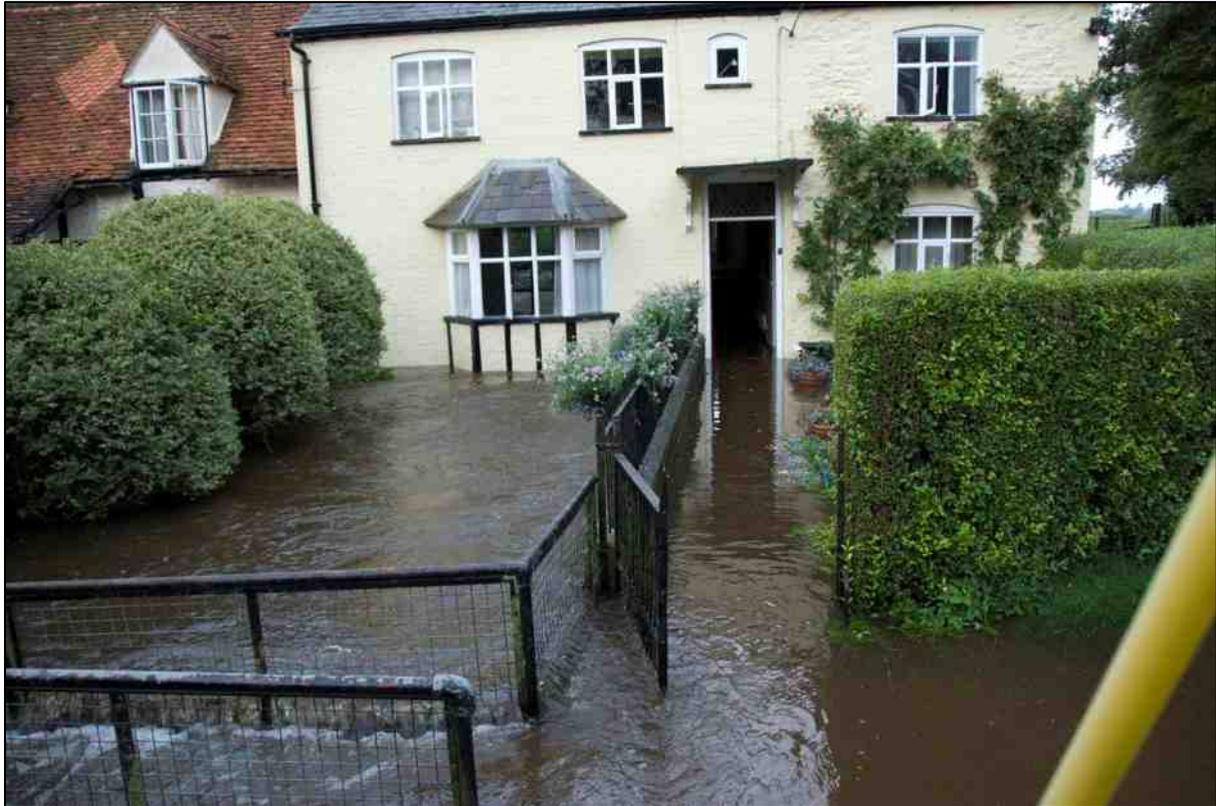
(McKnight, 2008). This is considerably more than the long term average rainfall over the Thames catchment for the full month of July at 49mm. The Environment Agency documented that 73 properties flooded in Steventon, but many properties were also flooded further downstream in Sutton Courtenay (Figure 8).

**Figure 8: Flooding of the Ginge Brook in Sutton Courtenay, July 2007.**

The flow of the Ginge Brook was particularly high for the 20<sup>th</sup> July event as the flows were already high following the very wet period over May, June and early July. The wet weather meant that soils which were normally dry at this time of year were saturated and the flow from the chalk fed springs was also high due to high inflow of groundwater. There was very little storage capacity for the ensuing extreme rainfall so much surface water flooding occurred, drains were overwhelmed and rivers burst their banks.

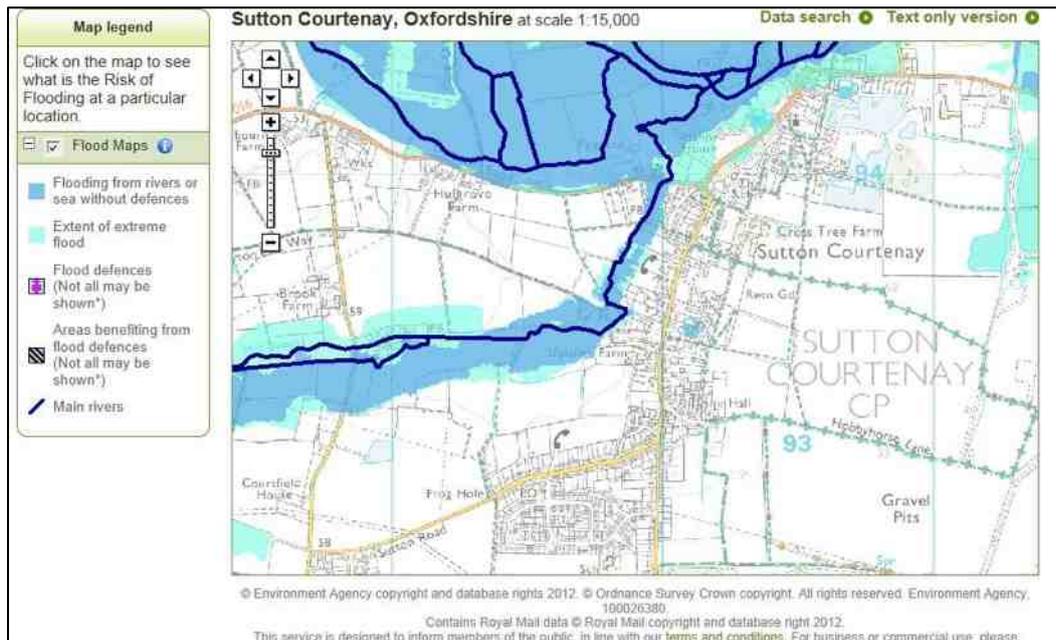
The Environment Agency flood risk maps show the predicted 1 in 100 year and 1 in 1000 flood outlines (Figure 9), which cover a significant part of Sutton Courtenay. The flooded area affected by the River Thames is generally to the north of the Drayton Road, while the Ginge Brook affects an area to the south of the Drayton Road. Although the River Thames flood outlines have been the result of a rigorous study using channel cross sectional surveys and detailed computer modelling, the flood outlines for the Ginge Brook have been generated from a general countrywide methodology which is not particularly accurate and only estimates the extent of flooding assuming a bankfull state of the river. This lack of accuracy is demonstrated by the fact that the predicted flood outlines for the Ginge Brook are not consistent with the course of the river as shown by the dark blue line on Figure 9. These maps on their own are not reliable enough to quantify the risk of flooding required for allowing development or insurance of property and a site specific study of the Ginge Brook should be made.

Figure 9: Environment Agency flood risk maps for the Ginge Brook at Sutton Courtenay.

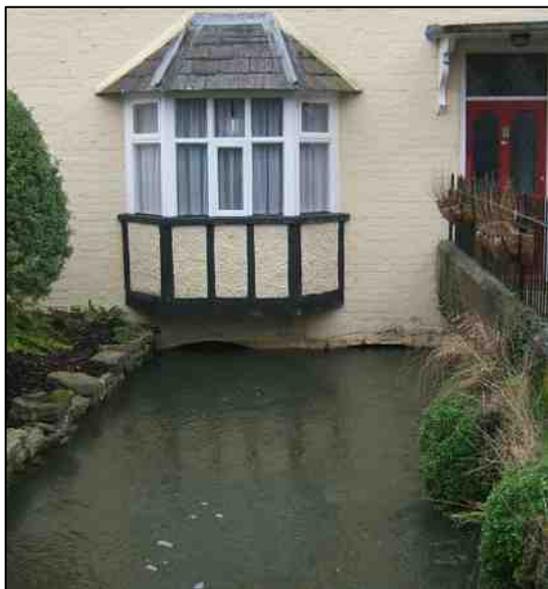
Figure 10: View of Ginge Brook in February 2013

An assessment was made of the flood risk at Lower Mill, the property shown in Figure 8 and 10, where the Ginge Brook actually flows in a culvert under the house, as shown in Figure 10. It should be stressed that the following text is just an initial assessment using rough measurements and estimates made during an inspection February 2013. A proper assessment would require detailed measurements of the channel and culvert at a number of cross sections along a reasonable reach length of the Brook (e.g. 500m) made using calibrated surveying equipment to an approved height datum. Hydrodynamic modelling would then be required, using specialist computer software to calculate the levels associated with different flows within the channel given the complexity of the channel shape.

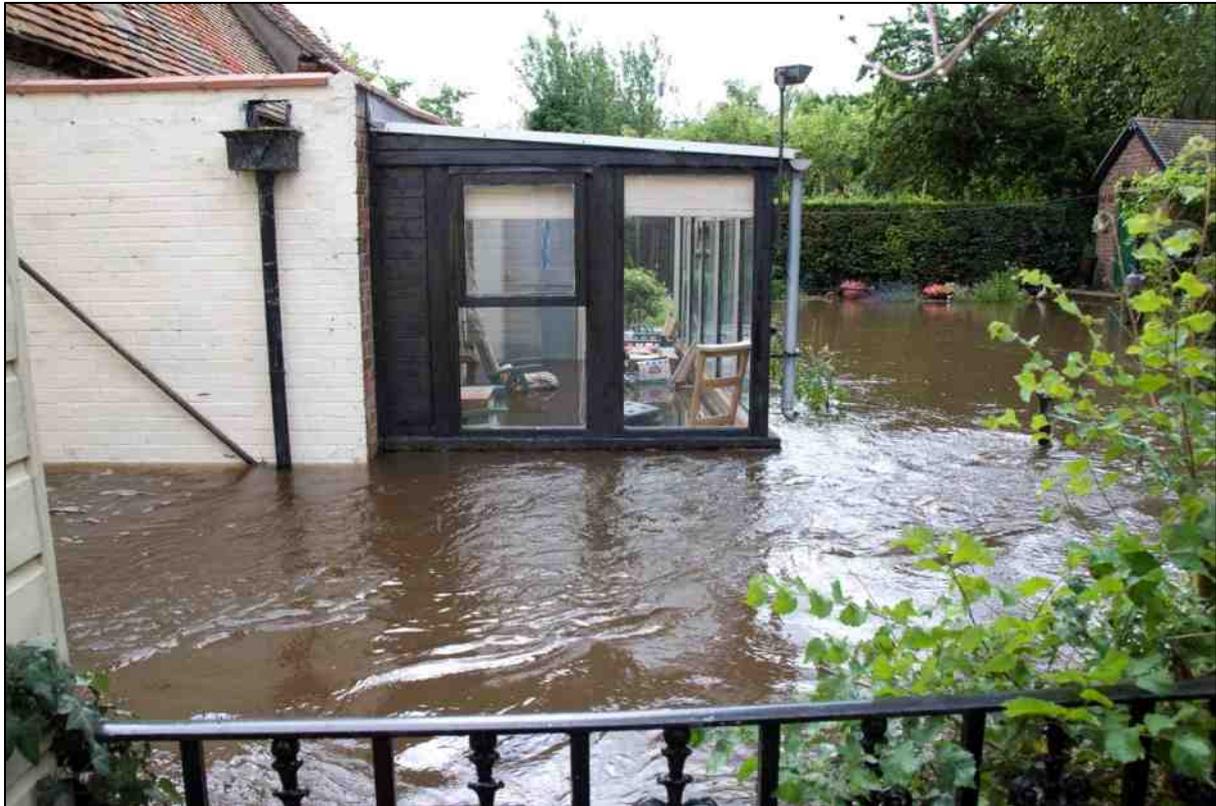
At the Lower Mill culvert, the channel is constrained so for the same flow to pass through the culvert as is observed in the river channel, the velocity must increase since the flow is the velocity multiplied by the cross sectional area. However at times of high flow, the increase in velocity cannot satisfy the confines of the culvert to convey the required flow so water will back up upstream of the culvert inlet, which is what happened in 2007. Water entered Lower Mill and neighbouring properties, as shown in Figure 11.

Figure 11: Flood water on the Ginge Brook immediately upstream of the Lower Mill culvert, showing the flooding of the neighbouring property.

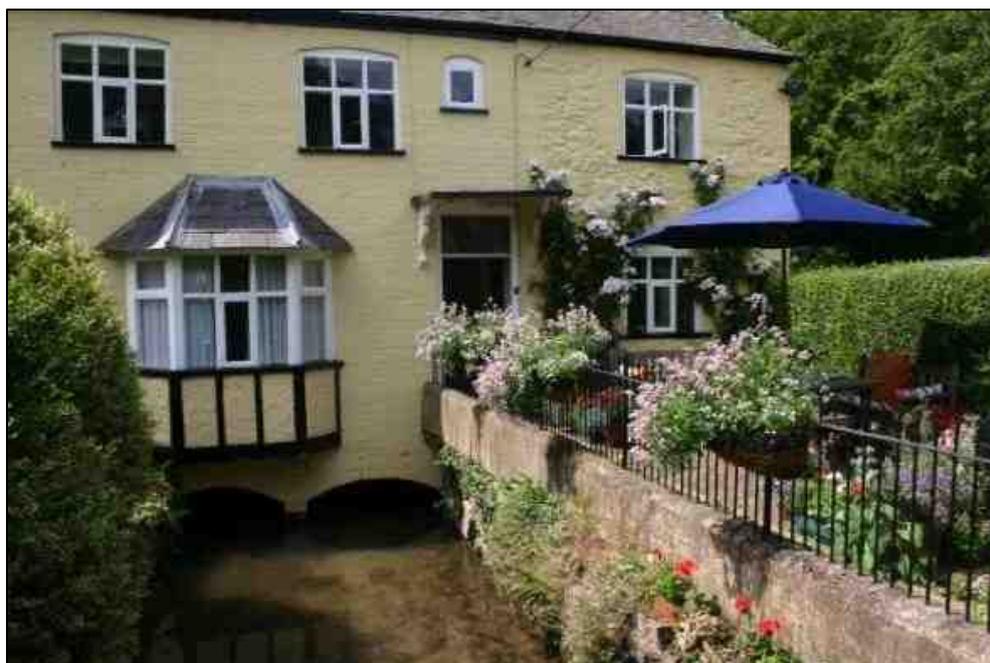
The channel just downstream of the culvert was measured as 2.8m wide with the current water levels (measured from the bed) of 0.4m at the edge and 0.5m in the centre of the channel. The current water levels were 0.35m below the top of the banks, as shown by the position of the low stone wall to the left in Figure 9. The flow in 2013 was high as it was during a period of flood alert issued by the Environment Agency. Using the cross sectional measurements and an single simple measure of velocity by timing the movement of a floating object over a measured reach the flow for the conditions in Figure 9 was estimated at 1.3 cumecs (cubic metres per second). Under low flow conditions (Figure 12) the culvert is clearly visible. The 2007 flood was considerably more than February 2013. Water is shown flowing over the footbridge in Figure 8, and the top of the footbridge is a further 0.25m above the bank top.

Figure 12: The Ginge Brook at Lower Mill during low flow conditions.
