**Proposed Residential Development, North of
Appleford Road, Sutton Courtenay, Oxfordshire,
OX14 4NF**

**Review of the Flood Risk Assessment produced by
Peter Brett Associates on Behalf of O & H
Properties Ltd**

**February 2016
Version 4: Final report including groundwater monitoring**

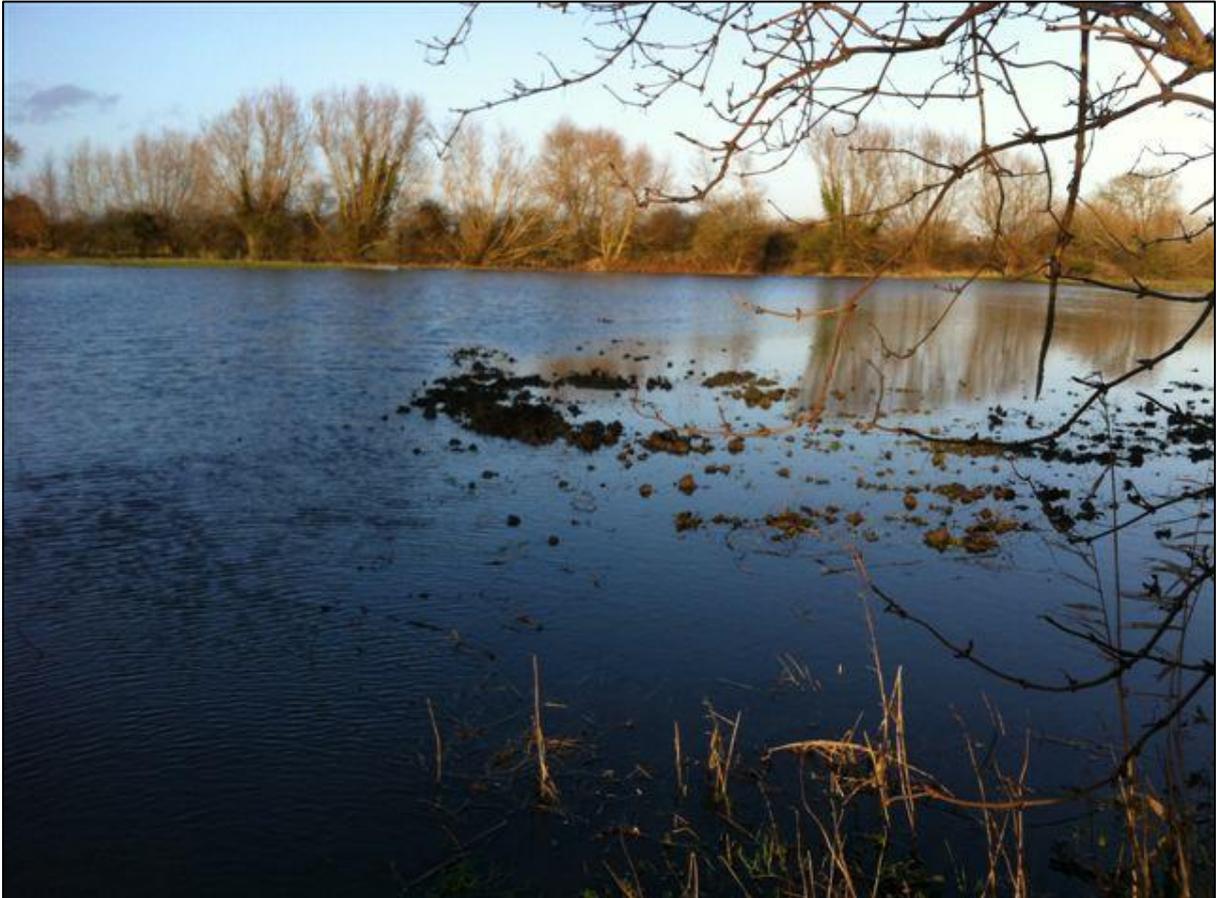
Figure 1. Groundwater flooding observed in Sutton Courtenay in February 2014.

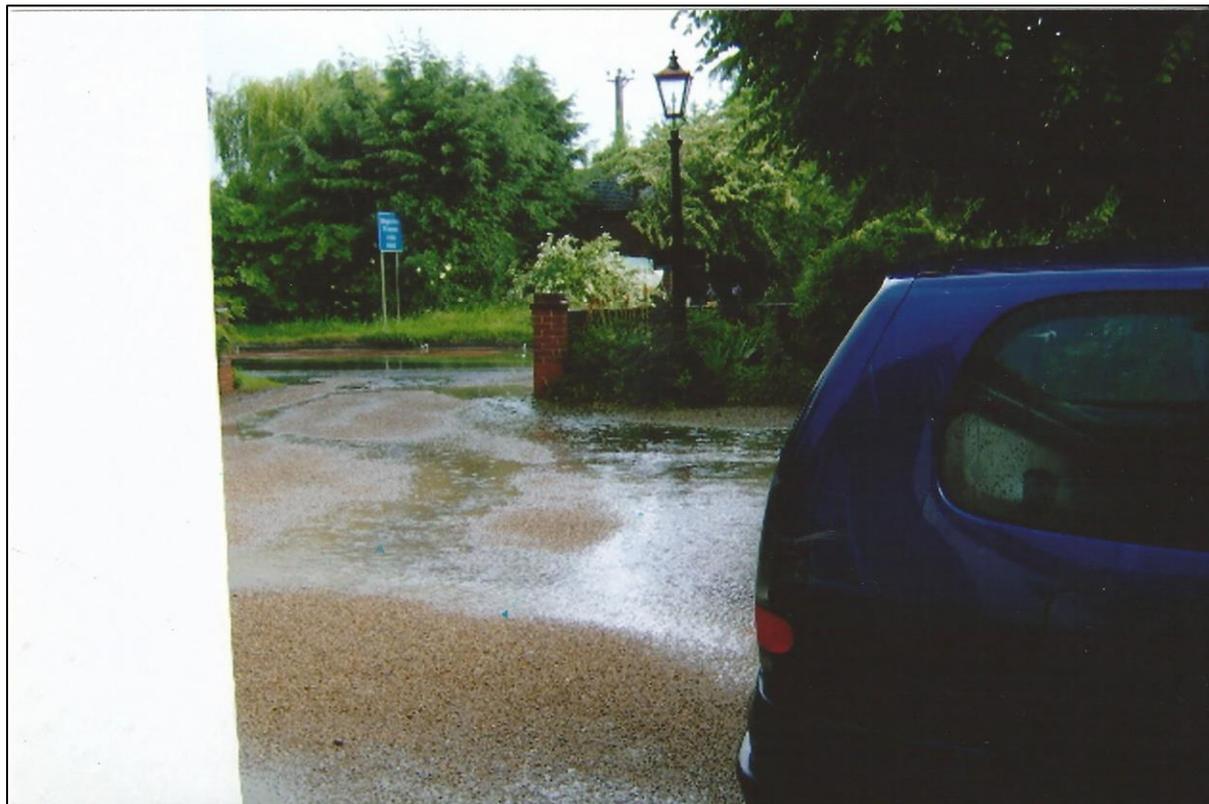
Residents have also observed floodwater from the Appleford Road flowing into properties as shown in Figure 2. This photo is at the entrance to 5 Appleford Road, which borders the south-west corner of the site and has a similar ground level to this part of the site.

Figure 2 Flooding at 5 Appleford Road in 2007 from surface runoff from the Appleford Road.

The proposed levels for access roads to the new development off the Appleford Road are not listed in the FRA and the proposed drainage layout is at a low resolution so spot heights are illegible. The FRA should discuss the risk of flooding posed by these access roads. Depending on the relative levels floodwater could flow onto the Appleford Road adding to the severity of flooding previously experienced or water from Appleford Road could flow into the site and affect the new houses. The FRA states that the ground floor levels of the houses should be set at a minimum of 300mm above the predicted 100 year plus climate change flood level, but this actual level is never stated in the FRA.

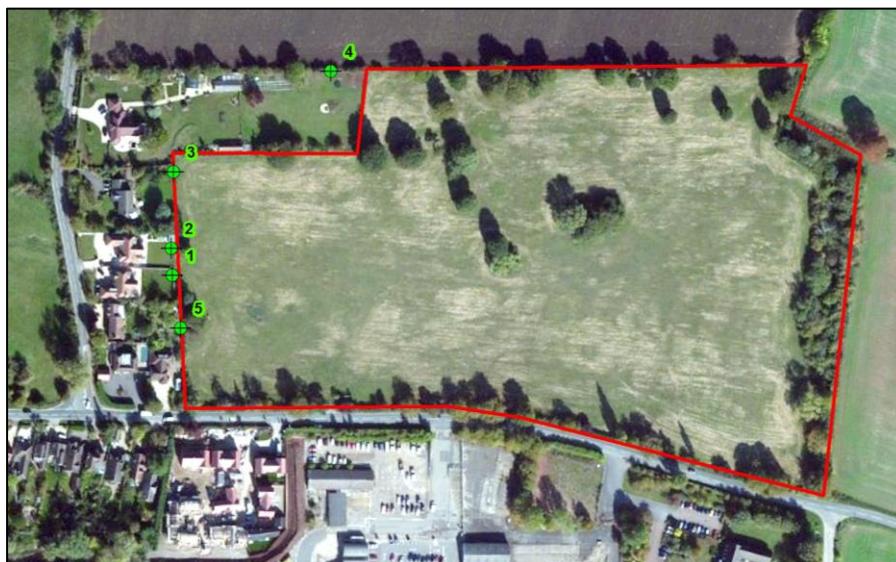
Figure 3. The location of boreholes along the boundary of the development site (red outline).

(ground level 48.94m AOD) water was struck at 0.9m below the surface (48.04m AOD). This is over a metre higher than the highest level given in the Ground Investigation Report. It is valid to assume that groundwater levels will follow the topography of the site, therefore groundwater within 1m of the surface could be expected along the northern part of the site where the ground surface is at or below 49.0m AOD.

Table 1. Groundwater levels at boreholes bordering the development site.

Borehole Number (Fig 3)	Borehole Depth (m)	Ground level (m AOD)	Water on 28/01/2015	Water level (m AOD)
1	0.97	50.88	N	
2	0.97	50.74	N	
3	0.72	49.51	N	
4	1.09	48.94	Y	48.04
5	0.97	50.80	N
