Proposed Residential Development, Land North of Hobbyhorse Lane, Sutton Courtenay, Oxfordshire

Review of the Sutton Courtenay Flood Risk Assessment produced by JNP Group on Behalf of Redrow Homes

**February 2016
Version 4: Final Report**

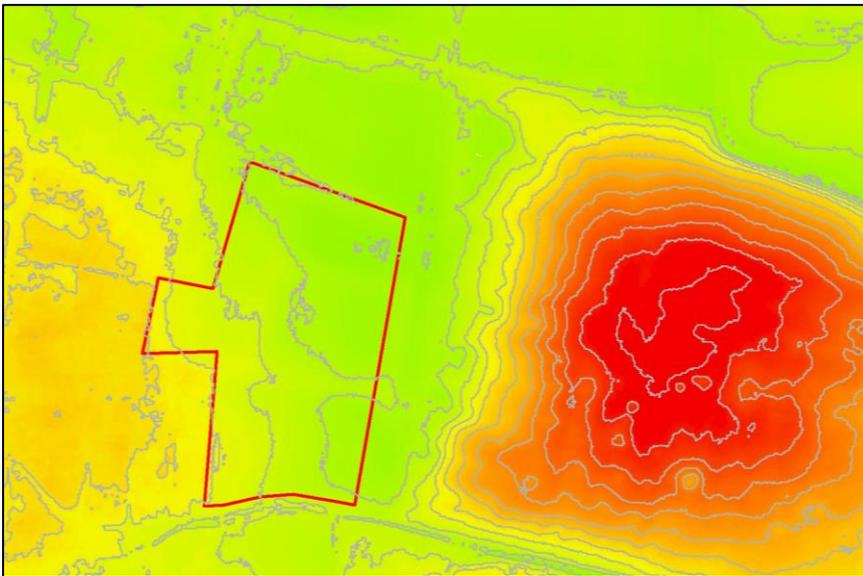
Figure 1. The topography of the area surrounding the development site (red outline) with levels ranging from 47.5m AOD (green) to 62.9m AOD (red), with 1m contours is grey. (Source: EA 1m resolution filtered LiDAR, scale 1:5,000)

the topography (Figure 1). The description misses the fact that the site is considerably lower than the existing residential land to the west and the capped landfill to the east. The fact that the site is considerably lower than the surrounding areas has implications in terms of the flood risk for the site receiving surface water and being at risk of flooding from high groundwater.

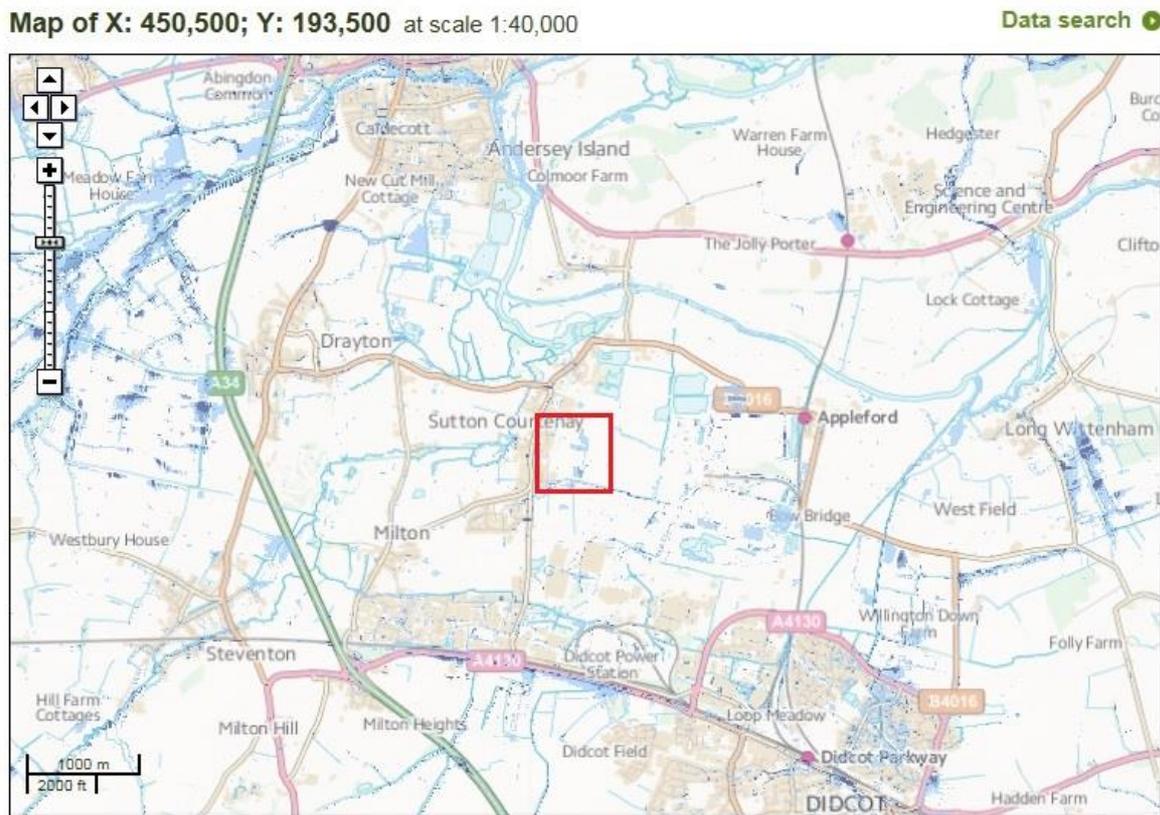
Figure 2. Surface water flood risk map showing areas within the development site (highlighted).

Critically the EA surface water flood risk map is not included as this shows a medium and high risk of surface water flooding over parts of the site (Figure 2). Also recent incidents of flooding of the site were observed in 2012 and again in 2014 (Figure 3). Furthermore the description of the hydrology identifies ditches along the northern and southern boundary of the site but neglects the presence of a ditch along the eastern boundary at the foot of the landfill. This ditch was also observed to be full and overtopping into the site in December 2012 (Figure 4). No further information has been provided about the catchment of these ditches nor have any assessments been made of the potential flood flows in the ditches and possible impacts on the site. In addition the recreation ground immediately to the north of the site is prone to flooding with water emanating from the upslope development site (Figure 5). The FRA does not give any detail on the how water from the development site can affect neighbouring areas.

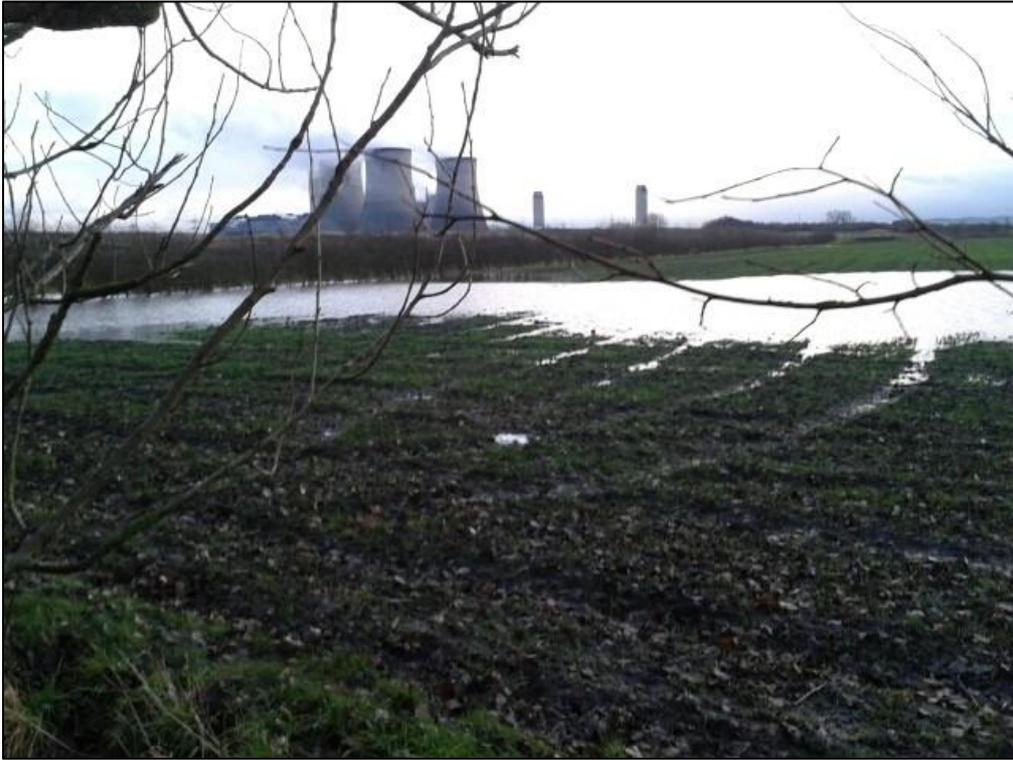
Figure 3. Flooding of the development site in February 2014, viewed from the northern boundary.

- Geological investigations at the site have measured groundwater 0.22m below the surface;
- Flooding of the site has been observed in 2012 and 2014 through a combination of surface water and high groundwater;
- The proposed surface water management promotes the use of infiltration measures with infiltration basins excavated 0.5m below the ground surface;
- SuDS guidance recommends infiltration to groundwater should not be used for surface water management when the water table is within 1m of the ground surface;
- The use of infiltration at the site for management of surface water will not function during the winter months when groundwater is high.

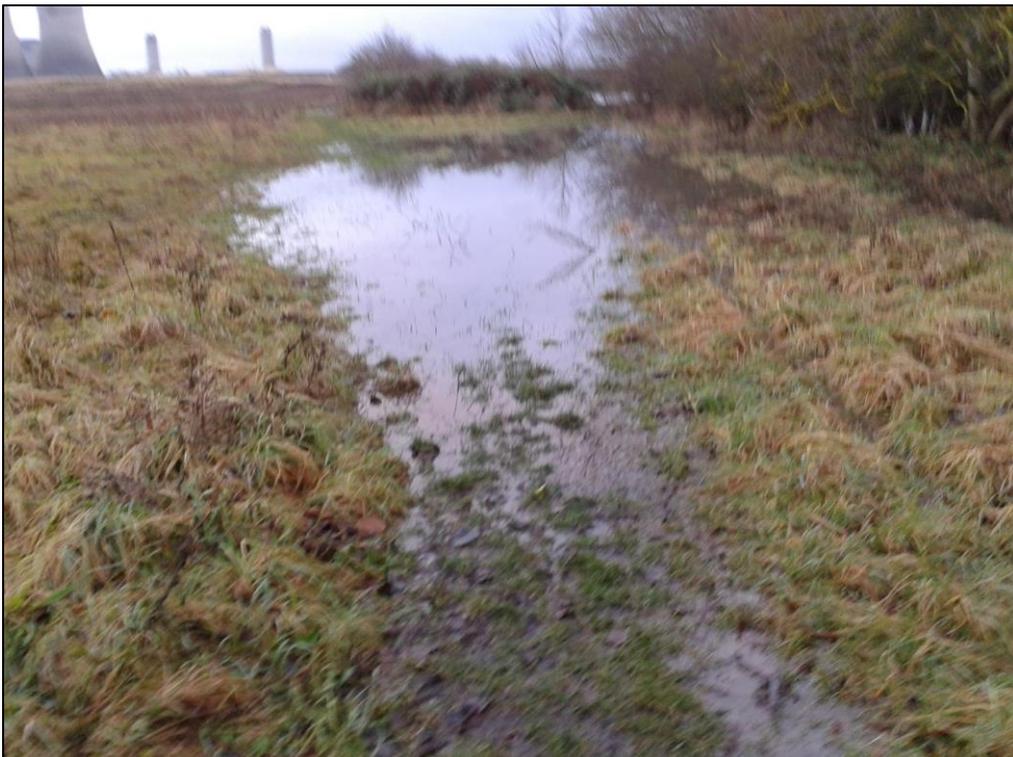
Figure 4. Flooding of the boundary ditch in 2012, looking south.

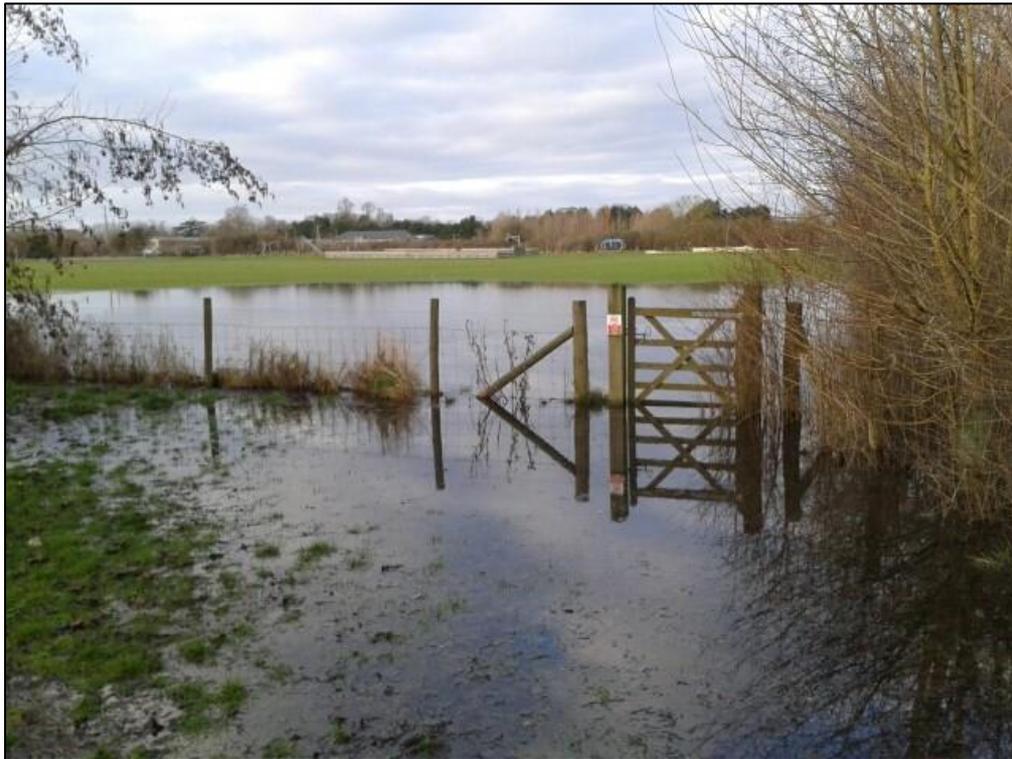
Figure 5. Flooding of the recreation ground in February 2014, viewed from the northern boundary of the development site.
